Javier Bru Roncallo

Master Thesis

Guidelines for Hull Condition Assessment Applicable to Single Skin Bulk Carriers on International Trade

OMCS CLASS
Overseas Marine Certification Services

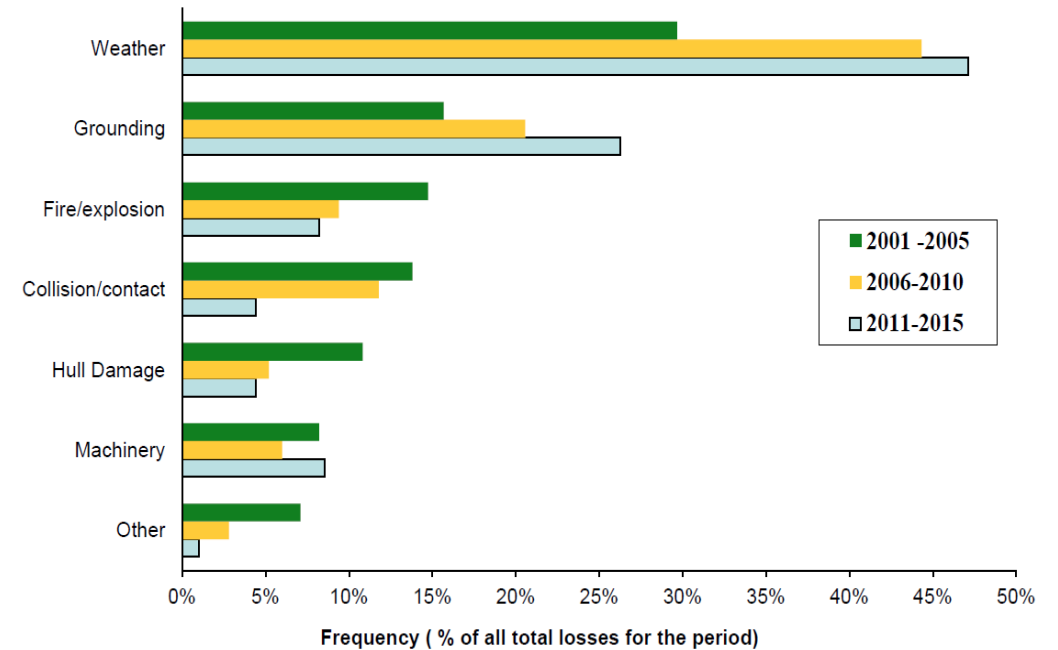
Total losses by causes for all vessel types greater than 500 GT ((IUMI), 2016)

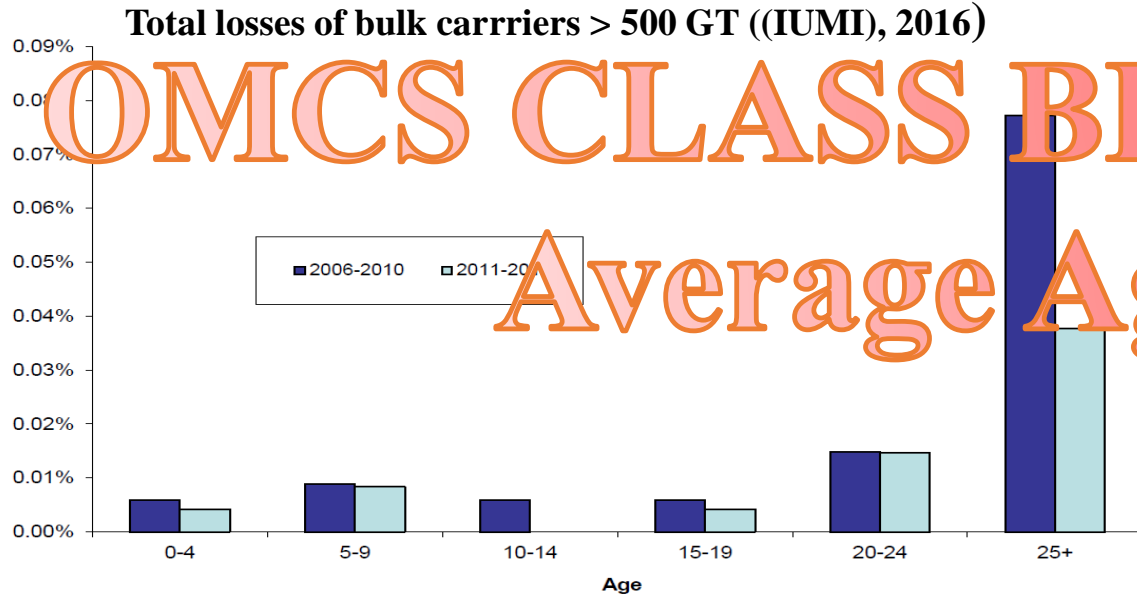
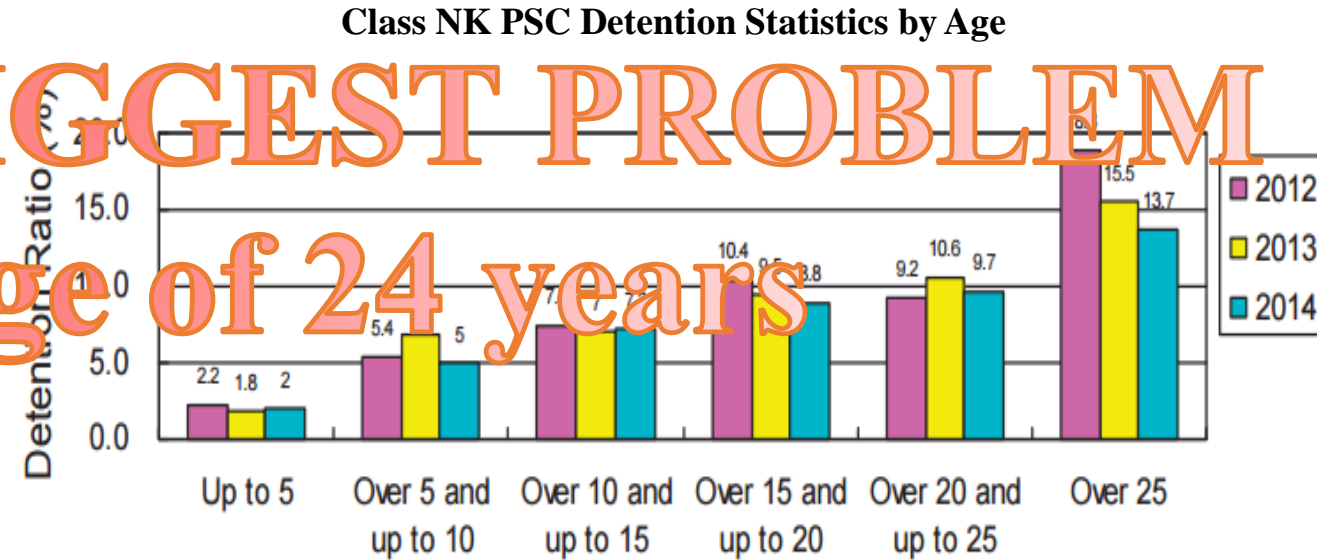
1) Ship Age

OMCS CLASS BIGGEST PROBLEM
Average Age of 24 years

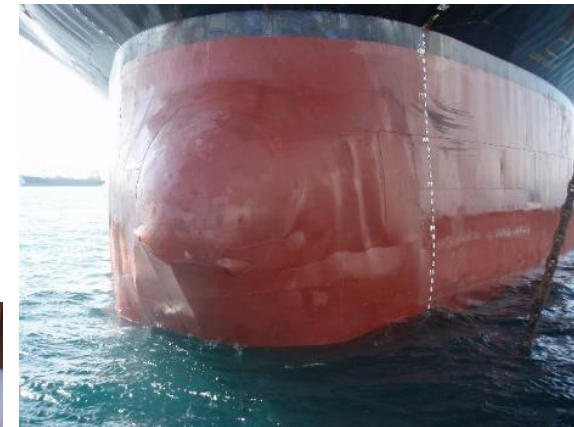
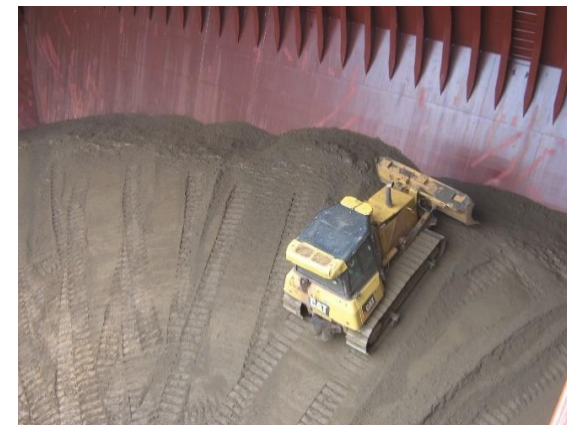
5) Mechanical Damages due to Wear & Tear

- Bulk Carriers have one of the toughest operational life of all commercial vessels.
- During the loading (cargo drop) and unloading (grabs, bulldozers)
- Corrosive Cargo

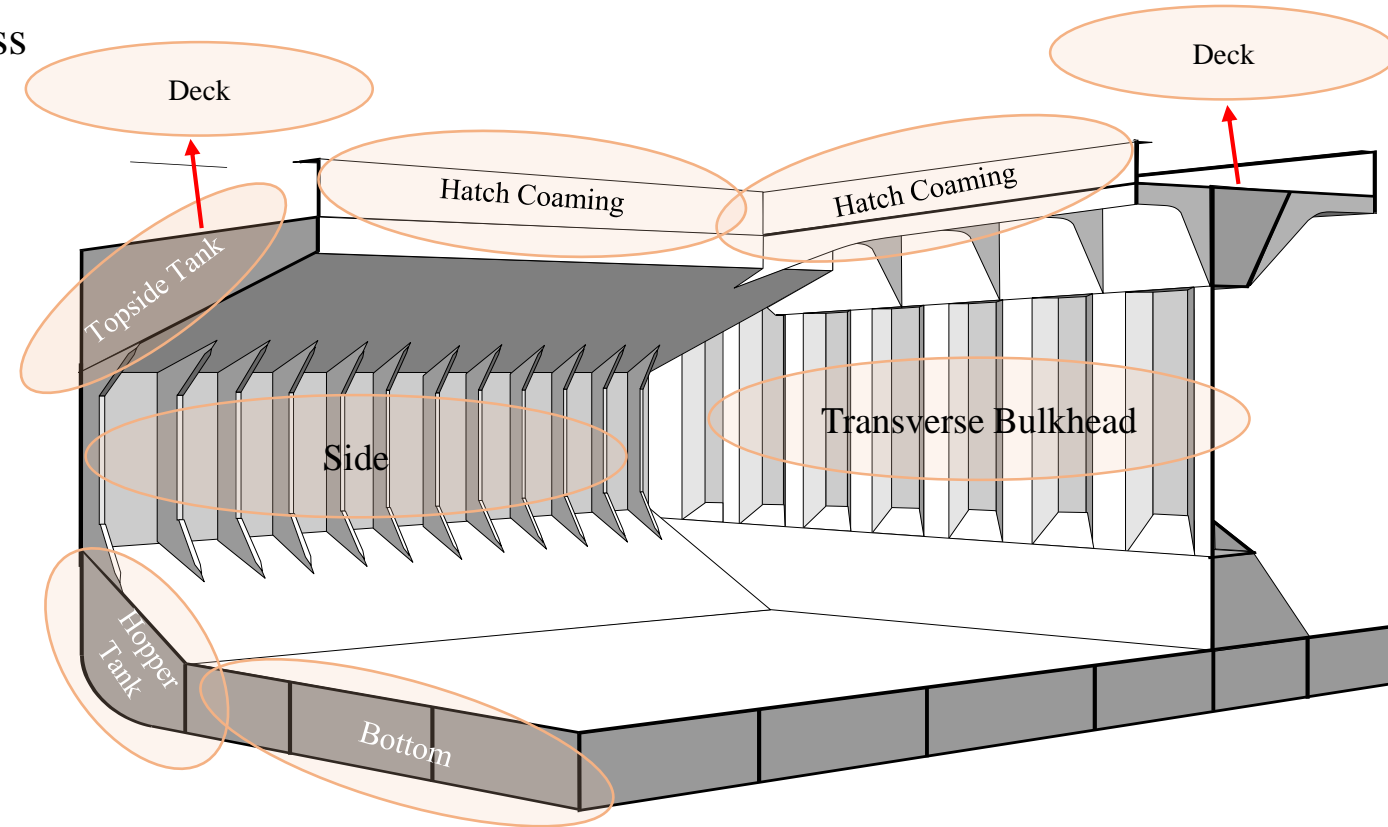
Seven (7) main structural regions:

- ✓ Side
- ✓ Bottom
- ✓ Deck
- ✓ Corrugated transverse bulkhead
- ✓ Topside tank
- ✓ Hopper tank
- ✓ Hatch coaming and cover

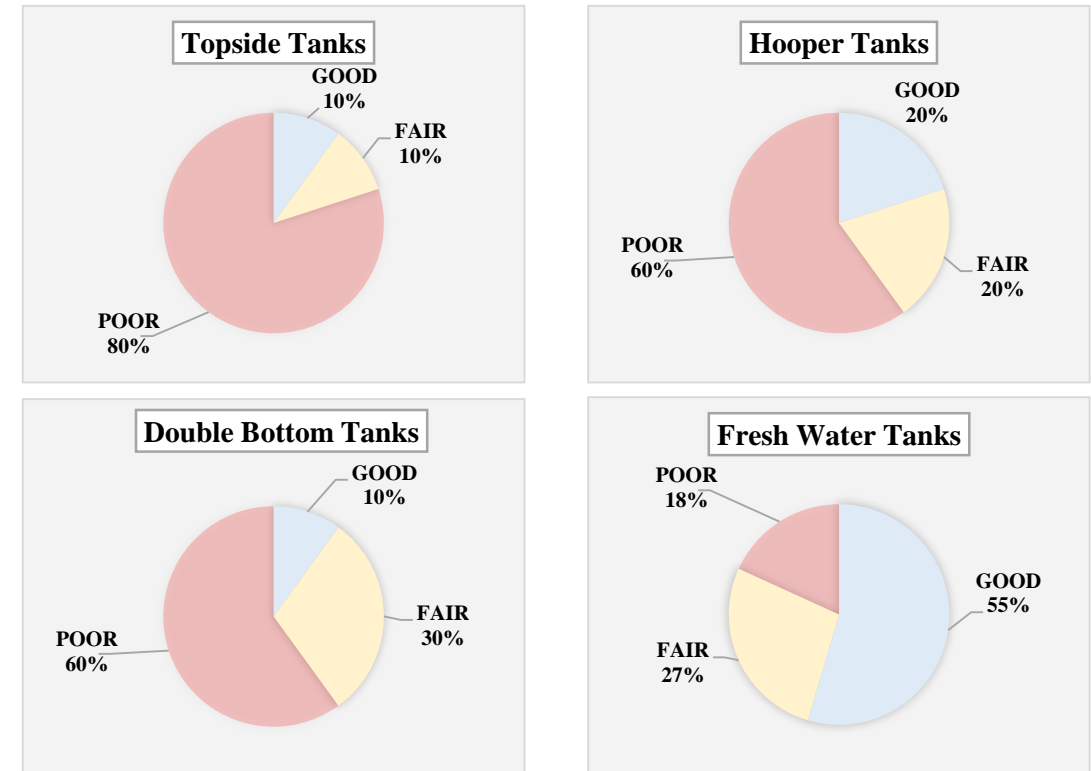
Status of Protective coatings

Ballast tanks, the corrosive protection system for the most part consist only of the presence of sacrificial anodes since the coating condition was rated POOR for most them. In particular, topside tanks were the ones worst rated.

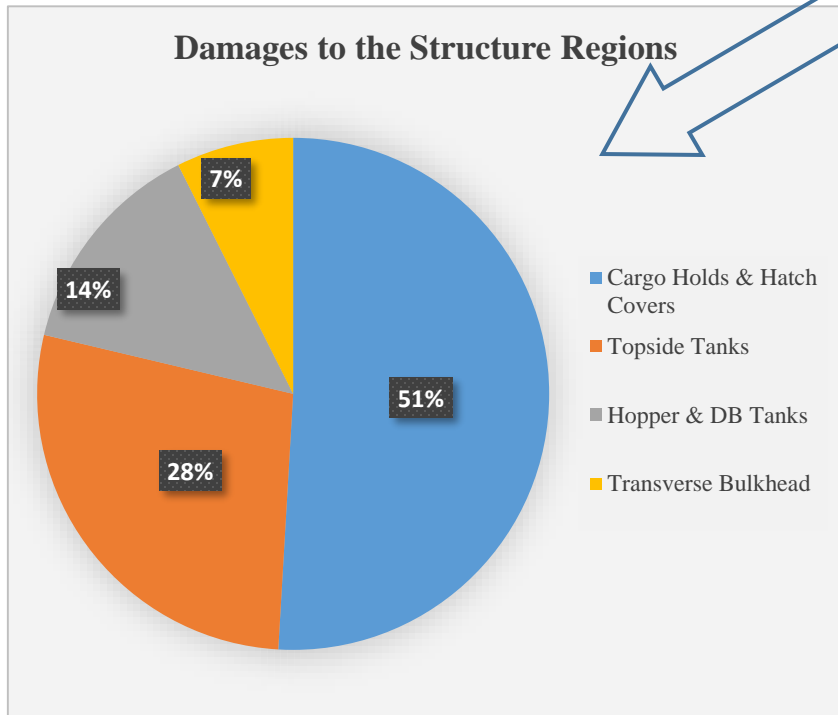
- Most common **defects** found were corrosion and cracks at areas of stress concentration
- All existing vessels (Built under IACS)
- TOCA enforcement could be improved

Most Common Defects found on OMCS CLASS Bulk Carriers
1.Generalized and localized corrosion of cargo hold side shell frames and brackets.
2.Cracking at cargo hold side shell frame bracket toes.
3.Excessive corrosion on hatch covers
4.Operational damages (grab & bulldozer) to the side shell frames lower brackets, inner bottom plating, hopper and lower stool plating. (Deformations (buckling and indentations)
5.Cracking at intersection of the inner bottom plating and the hopper plating.
6.Cracking at fore and aft extremities of topside tank structures.
7.Excessive corrosion within topside tanks (Frames, longitudinal stiffeners and brackets).
8.Excessive corrosion within Hopper and Double Bottom tanks (Frames, longitudinal stiffeners and brackets).
9.General corrosion and cracking of transverse bulkheads.
10.Cracking of hatch coamings & hatch corners.
